“Supporting the Marque”
By
Keeping It Cool

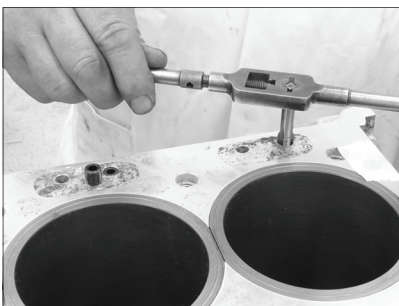
Picture 1

Over heating due to insufficient water flow.

Drill and tap two holes; one at each cylinder position. **Picture 1**. Then insert two 1/8” BSPT socket drive plugs and secure with thread sealant. Drill required 11/32” Dia. Tap required 1/8” BSPT. Socket drive plug required 1/8” BSPT. To increase flow to the rear of the engine. Drill one hole 23/64” Dia. between the two existing holes at cylinders 5 and 6. **Picture 2**. Drill or punch holes in gasket to match. Drill required 23/64” Dia
