“Supporting the Marque”
By
Keeping It Cool

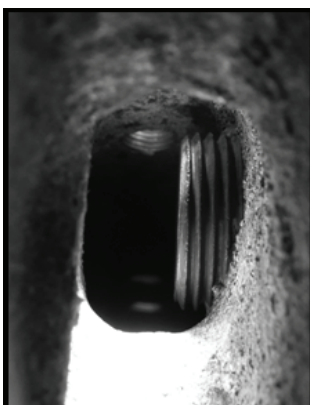
Picture 1

The existing water gallery plugs, on the exhaust side of the block, impede the flow of water. [Picture 1.](#)
