**“Supporting the Marque”  
By  
Keeping It Cool**

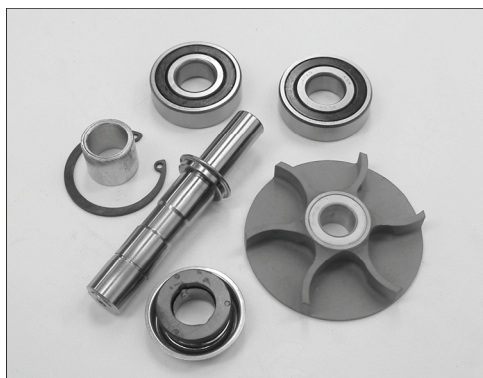
Over heating due to lack of water flow and circulation. Specifically at low speed.

To increase water flow by up to 30%, achieved by up rating existing water pump with JMB redesigned hi-flow impellor and ancillary parts.
